**CONSOLIDATION
OF THE OUTLET FOR LAKE LOUISA**

TOWNSHIP OF WENTWORTH

Excerpt from the plans
prepared by Miroslav
Chum, Inc.

May 3, 2021

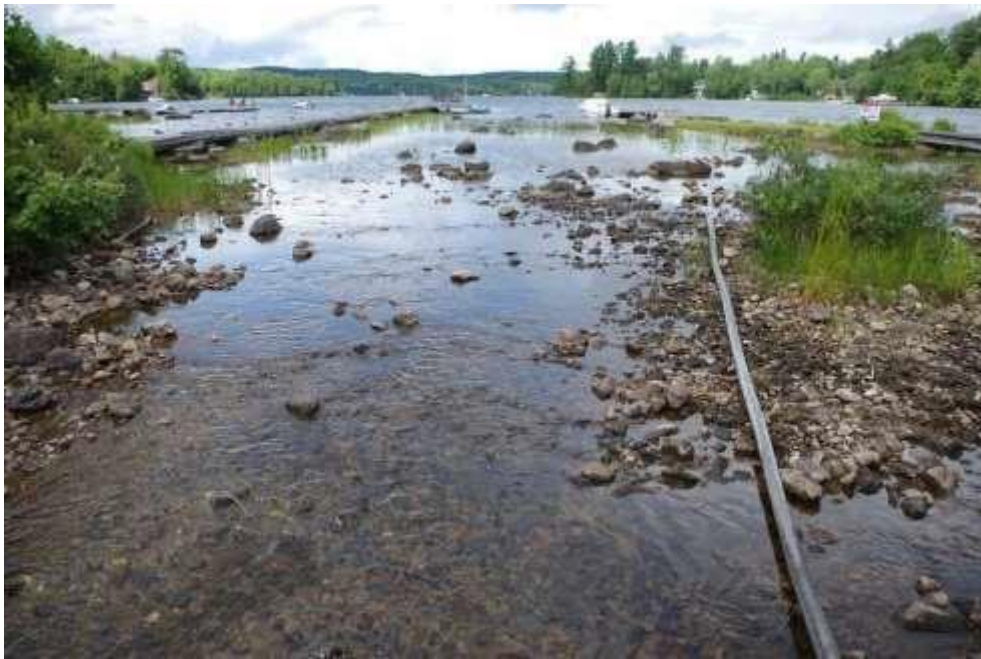
Photo 1 View of Lake Louisa from the outlet.

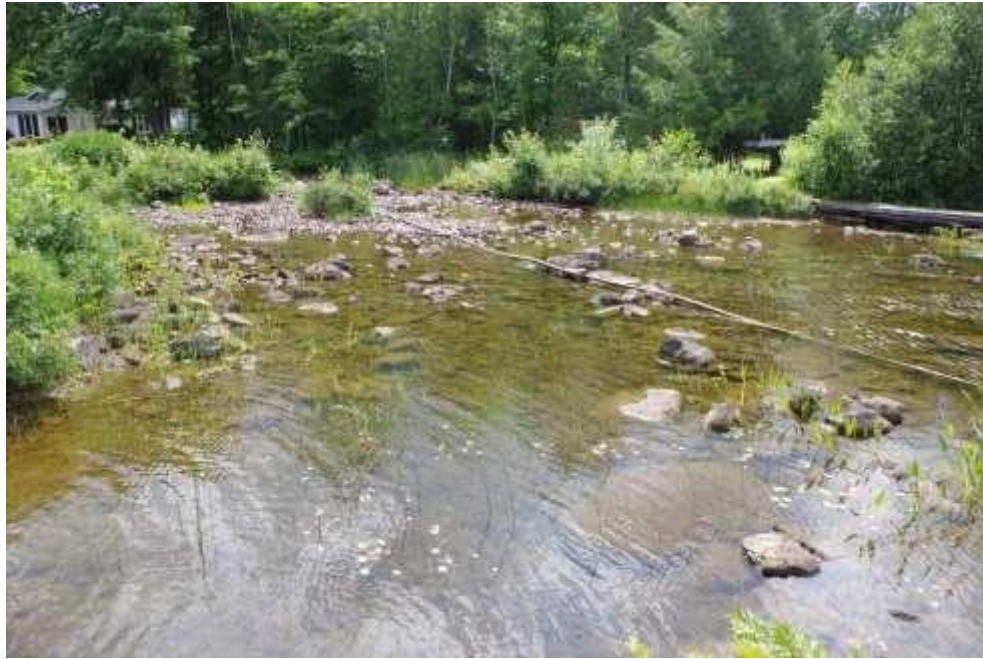
The lake outlet is mainly composed of high-caliber granular material (photos 2, 3 and 4). The difference between the lake and its emissary (unnamed water courses) is relatively small, not exceeding 0.80 m. Since the length of the outlet is more than 25 m long, the longitudinal slope is relatively small, reaching an average inclination of about 1: 30.

Photo 2 View from the lake on the outlet.

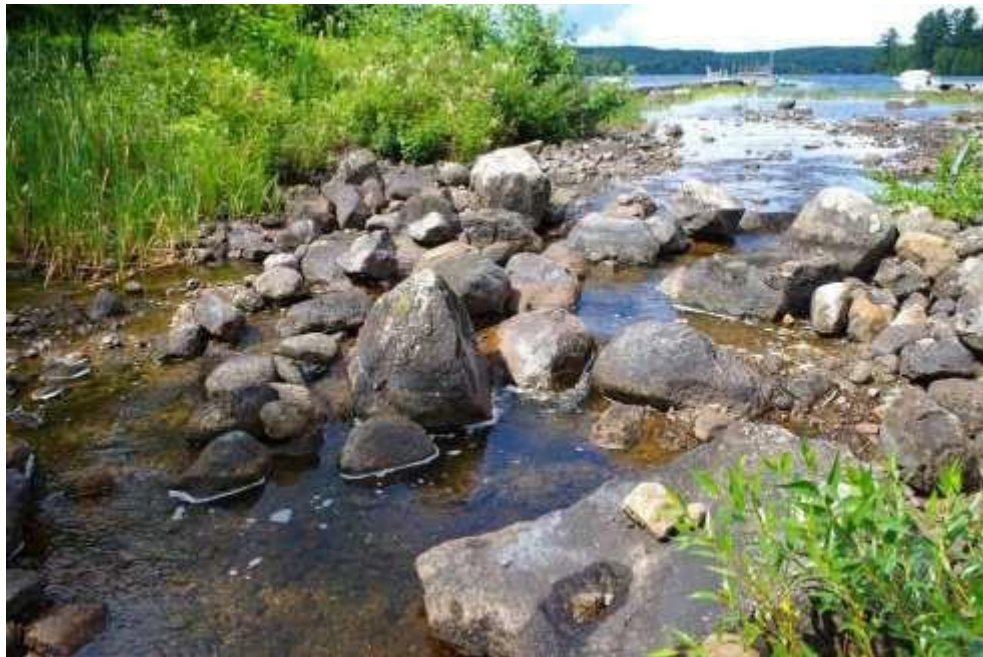
Usually, in the natural environment, a longitudinal slope of this order does not represent a particular difficulty for the free movement of fish. However, in this case, high granulometry is responsible for a significant percolation of water through the rocks. Indeed, during periods of stretching, almost all the flow is transited through interstices. Naturally, this type of flow is not compatible with fish migration. In addition, the high percolation over the entire width of the outlet (about 20m wide) is responsible for the significant lowering of the lake's water level, while degrading the water environment and adjacent wetlands.

Photo 3 The outlet is made up of large stones. During periods of low water, the extensive percolation through the rocks makes the free movement of fish impossible.

In order to stabilize the flow conditions and preserve the quality of the water environment of Lake Louisa, it is proposed to consolidate the section of the outlet with rocks of a spread granulometry. A notch will be built in the spillway to concentrate the flow associated with the low-water regime and to facilitate the free movement of the fish species present.

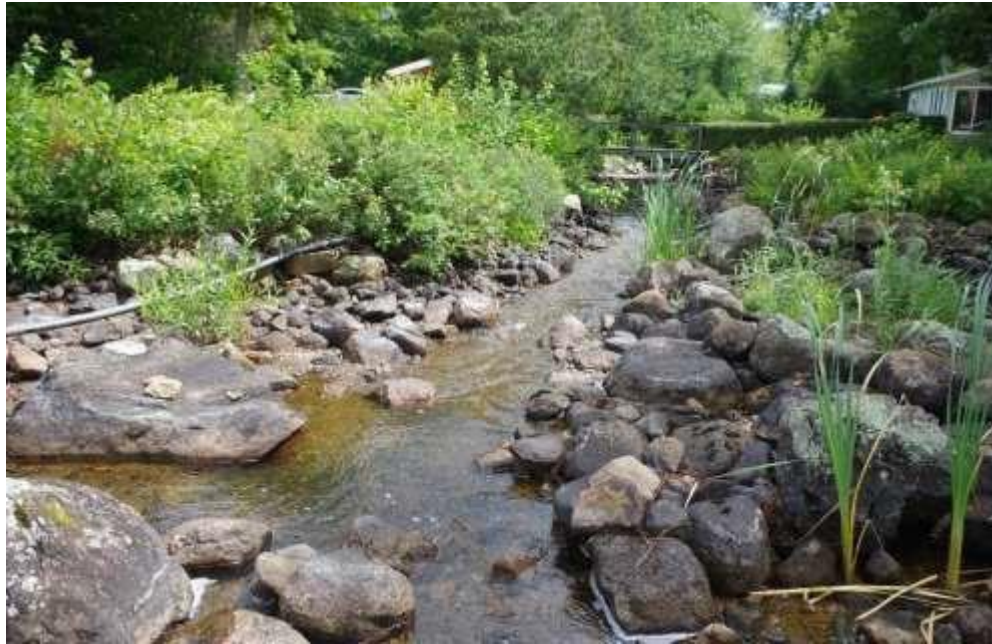
Photo 4 In the downstream part of the outlet, it appears that the flow was channeled by anthropogenic interventions. During periods of low water, these interventions contribute to the lowering of the water level of Lake Louisa.

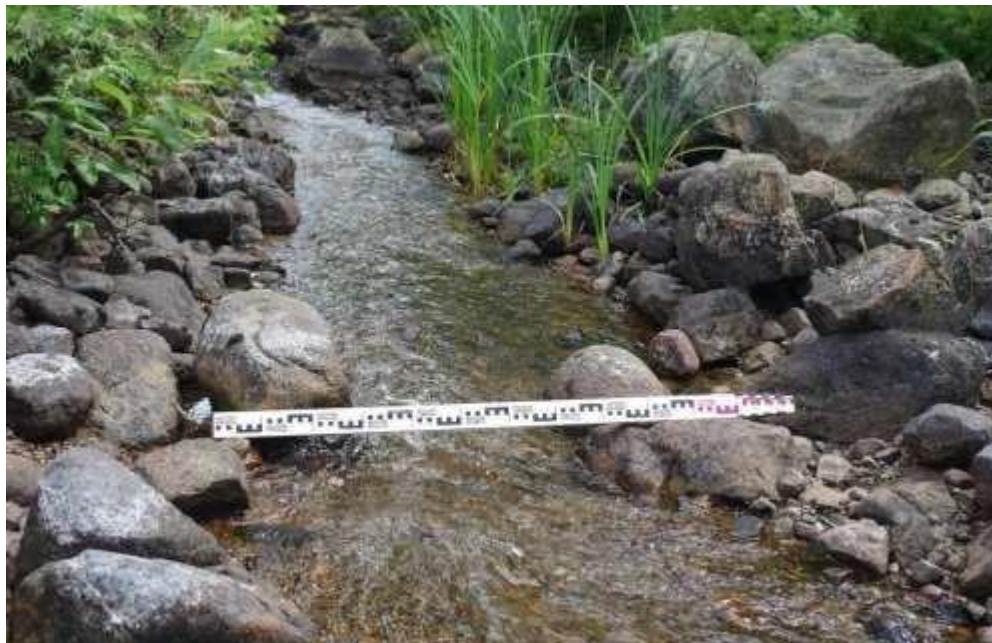
The emissary of Lake Louisa is relatively narrow and flows into Mud Lake, located about 150 m further downstream (photo 5). It should be noted that no other obstacles to free movement have been observed between the two bodies of water.

Photo 5 Between the outlet of Lake Louisa and the south Lake Louisa road, the stream is relatively narrow and straight.
